NASA CR-72966
R-8494-2

ROTATING AND POSITIVE-DISPLACEMENT PUMPS
FOR
LOW-THRUST ROCKET ENGINES

FINAL REPORT
VOLUME II
FABRICATION AND TESTING

ROCKETDYNE DIVISION
ROCKWELL INTERNATIONAL
CANOGA PARK, CALIFORNIA

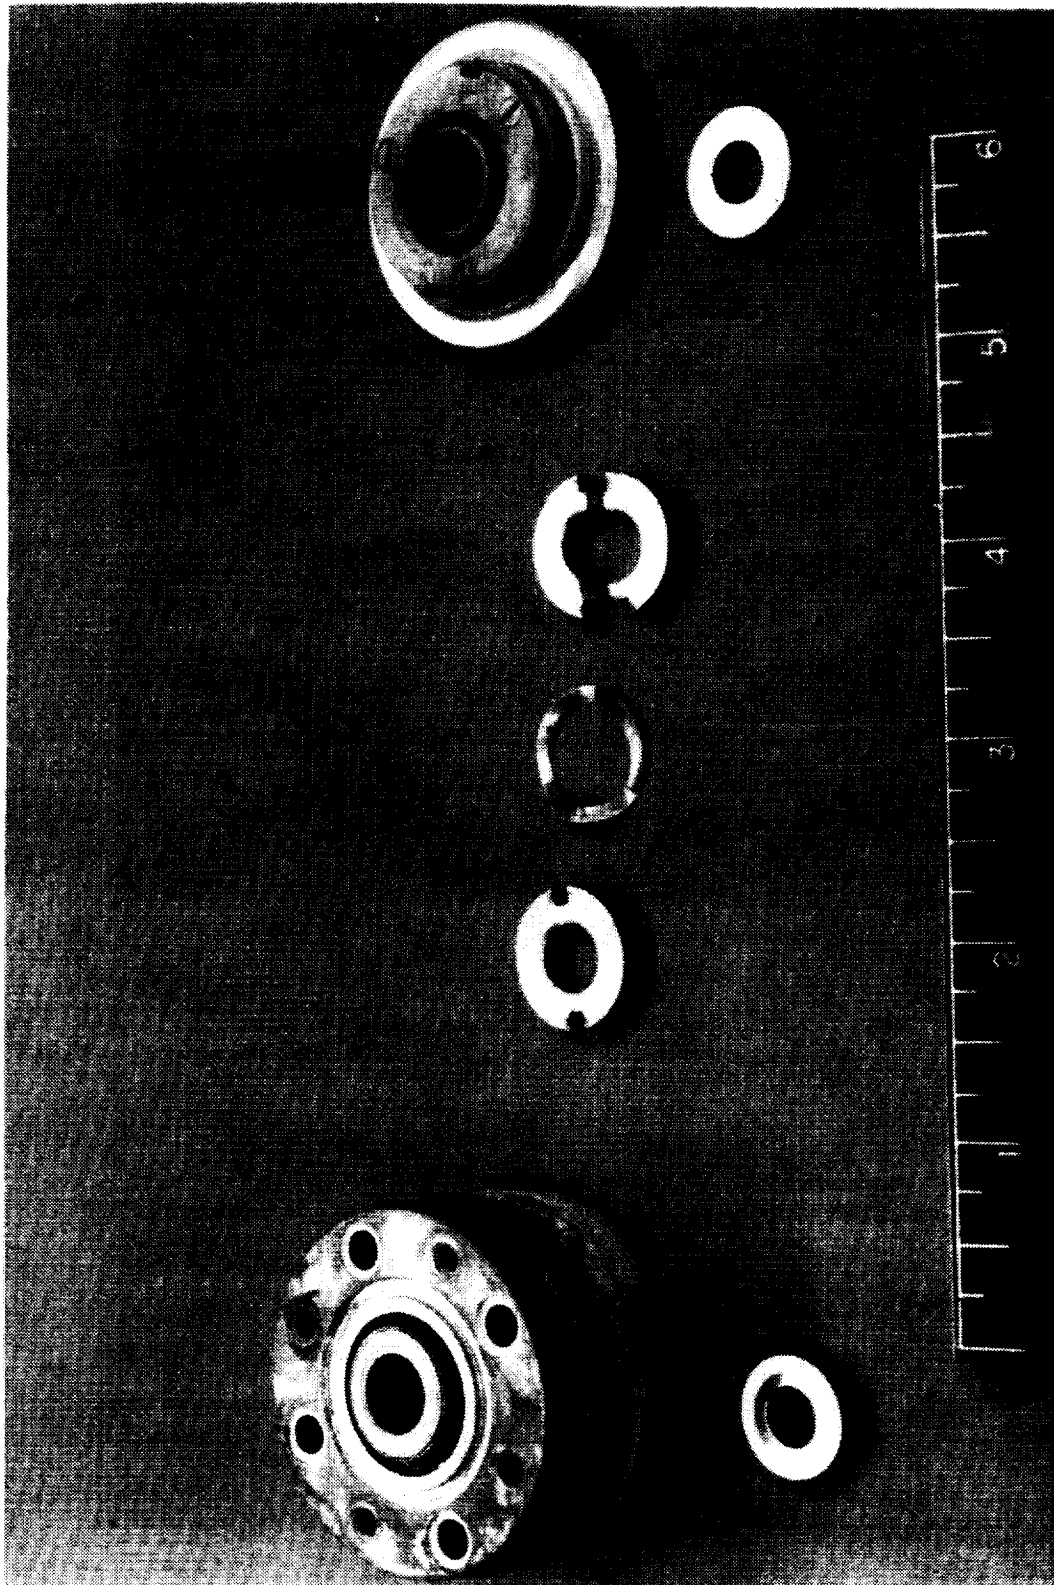
1XY55-4/5/71-CIC

Seals. Figure 40 shows the shaft dynamic seals after turbopump disassembly. The aluminum oxide rubbing surfaces on the primary seal nose and mating ring were in good condition. The wear on the mating ring was .0002 inch (5.1×10^{-6} m). The nose on the seal housing wore unevenly with approximately .004 inch (1.02×10^{-4} m) wear on one side and practically no wear at a point diametrically opposed. There was evidence of fluorine leaking past the flange seals and combining with moisture from the turbine drive gas to corrode the primary seal housing. Pressure check of the primary seal bellows showed no cracks.

Figure 40. Mark 36 Seals After LF_2 Testing

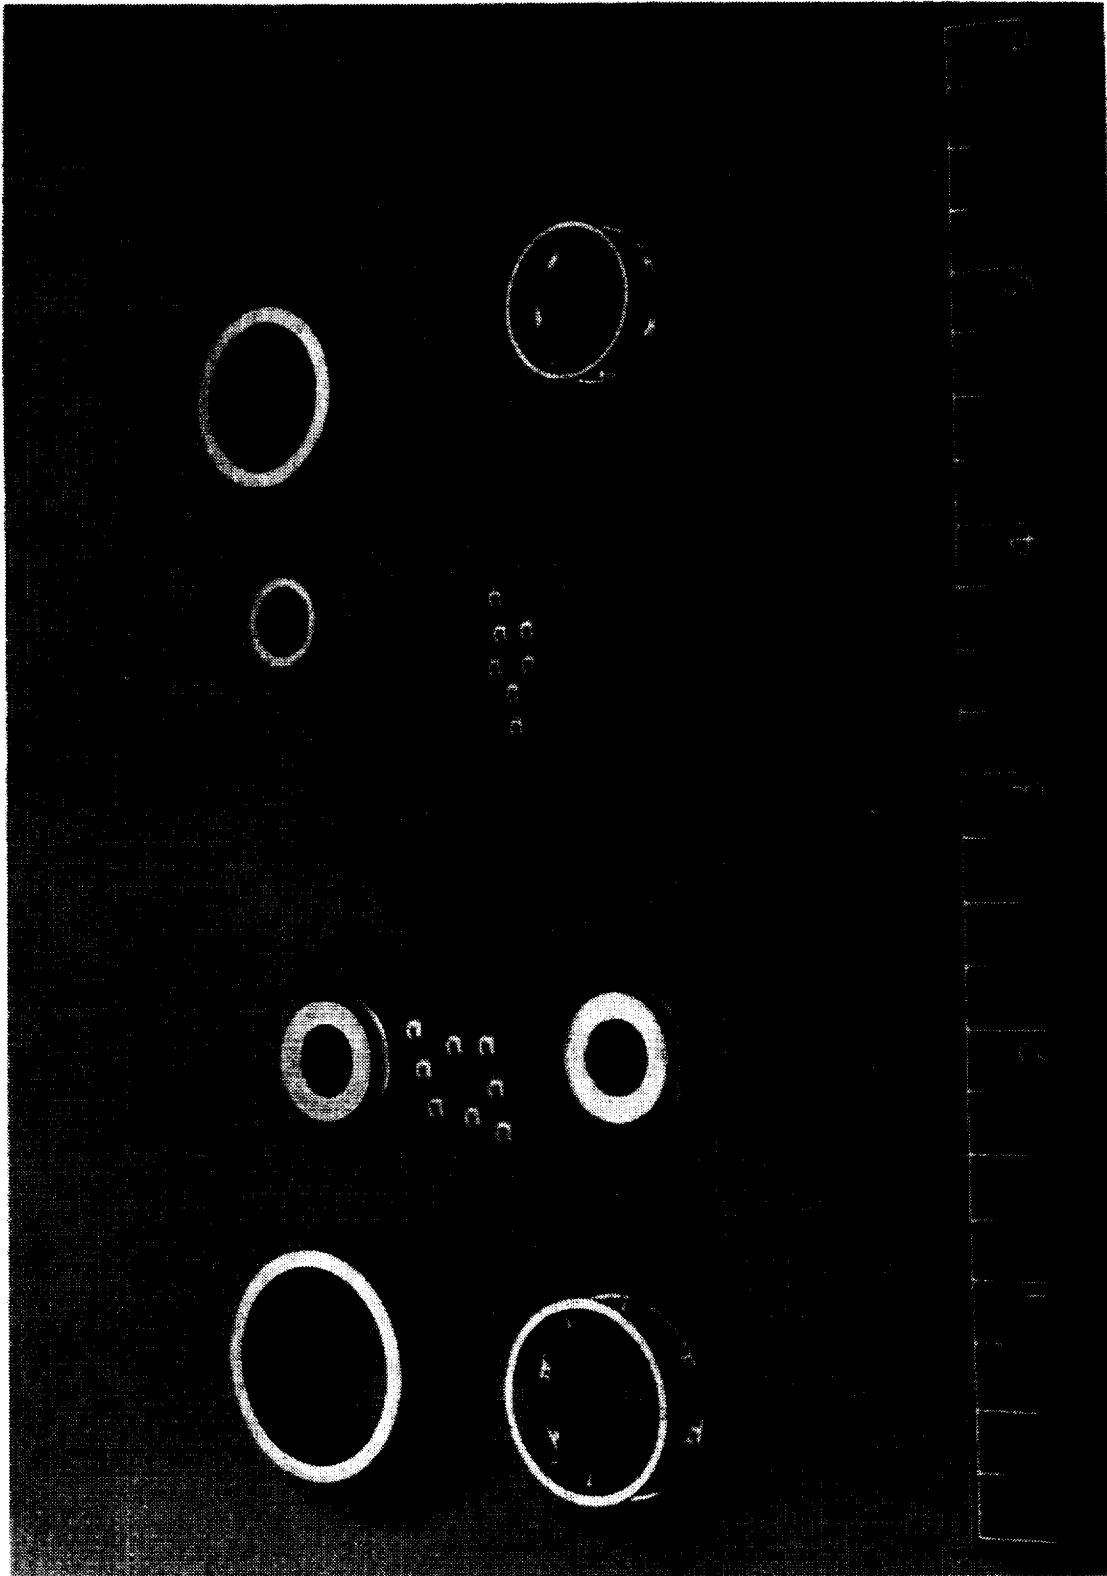
1XY55-4/5/71-CID

Figure 41. Mark 36 Bearings After LF₂ Testing

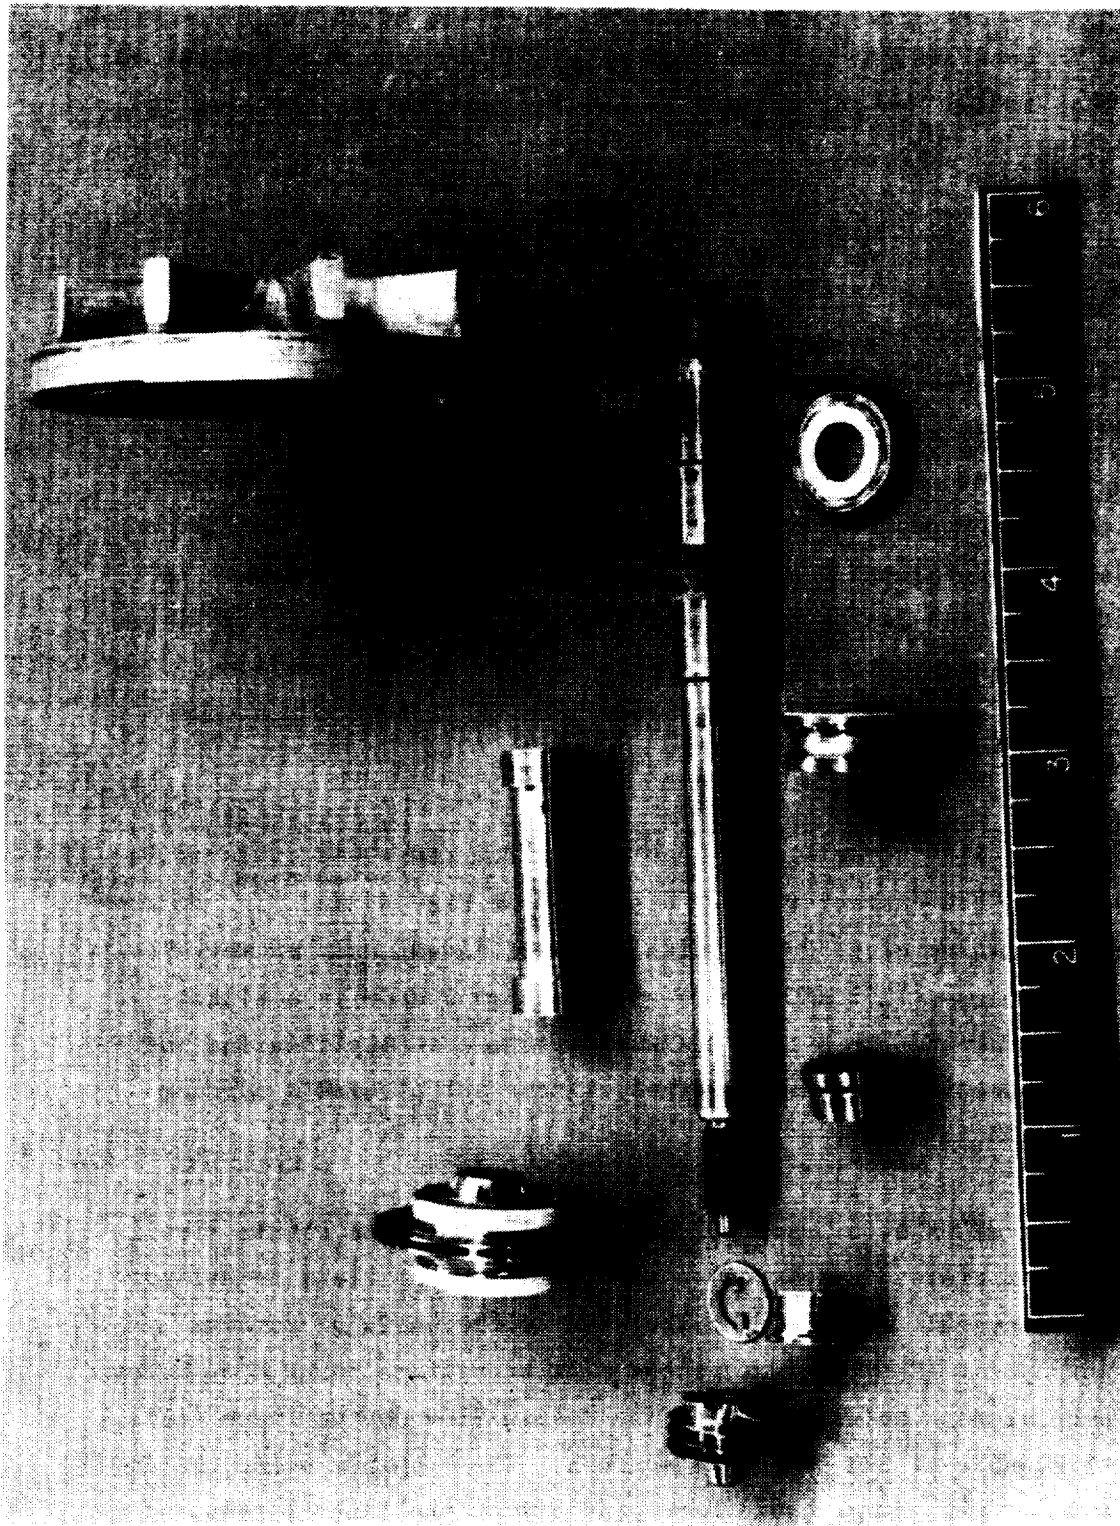
IXY55-4/5/71-C1A

Figure 43. Mark 36 Rotating Parts After LF_2 Testing

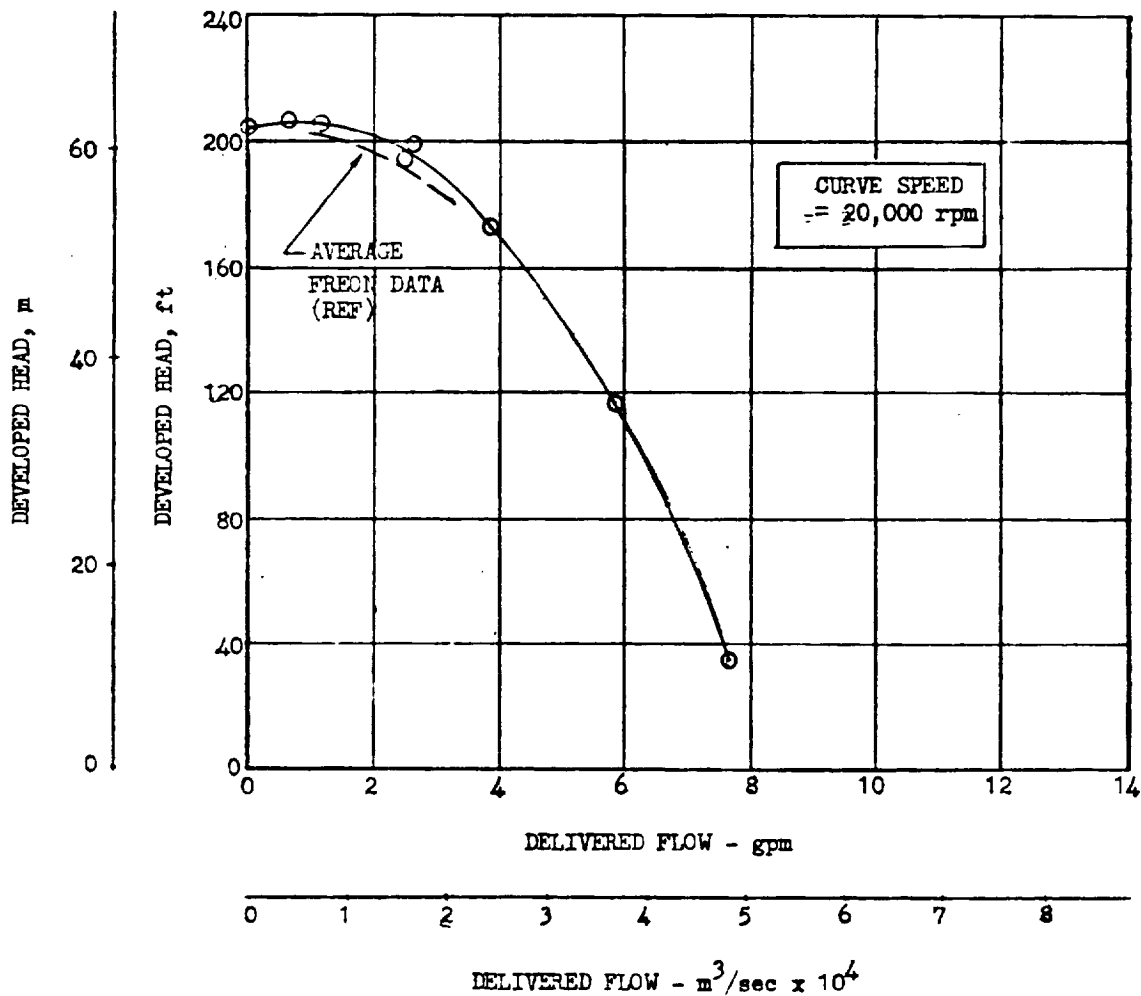
INDUCER DIA. CLEAR = .011 in (2.8×10^{-4} m)
 IMPELLER WEAR RING CLEAR (FRONT) = .006 in (1.53×10^{-4} m)
 IMPELLER WEAR RING CLEAR (REAR) = .0031 in ($.76 \times 10^{-4}$ m)

Figure 44. Mark 36 (12 gpm) Centrifugal Pump Test No. 02
 H-Q Characteristics in Liquid Fluorine

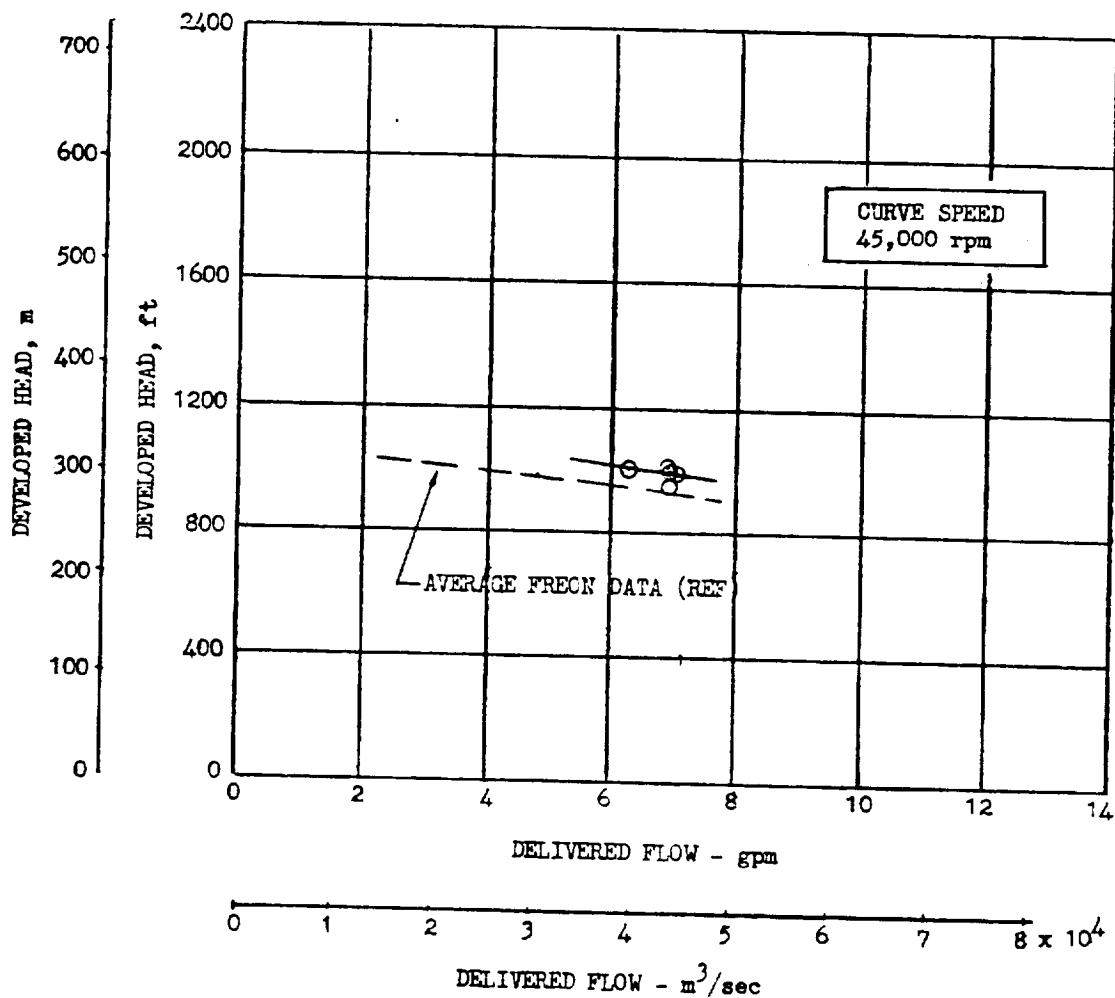
INDUCER DIA. CLEAR = .011 in (2.8×10^{-4} m)
 IMPELLER WEAR RING CLEAR (FRONT) = .066 in (1.53×10^{-4} m)
 IMPELLER WEAR RING CLEAR (REAR) = .0031 in ($.76 \times 10^{-4}$ m)

Figure 45. Mark 36 (12 gpm) Centrifugal Pump Test No. 03
 H-Q Characteristics in Liquid Fluorine

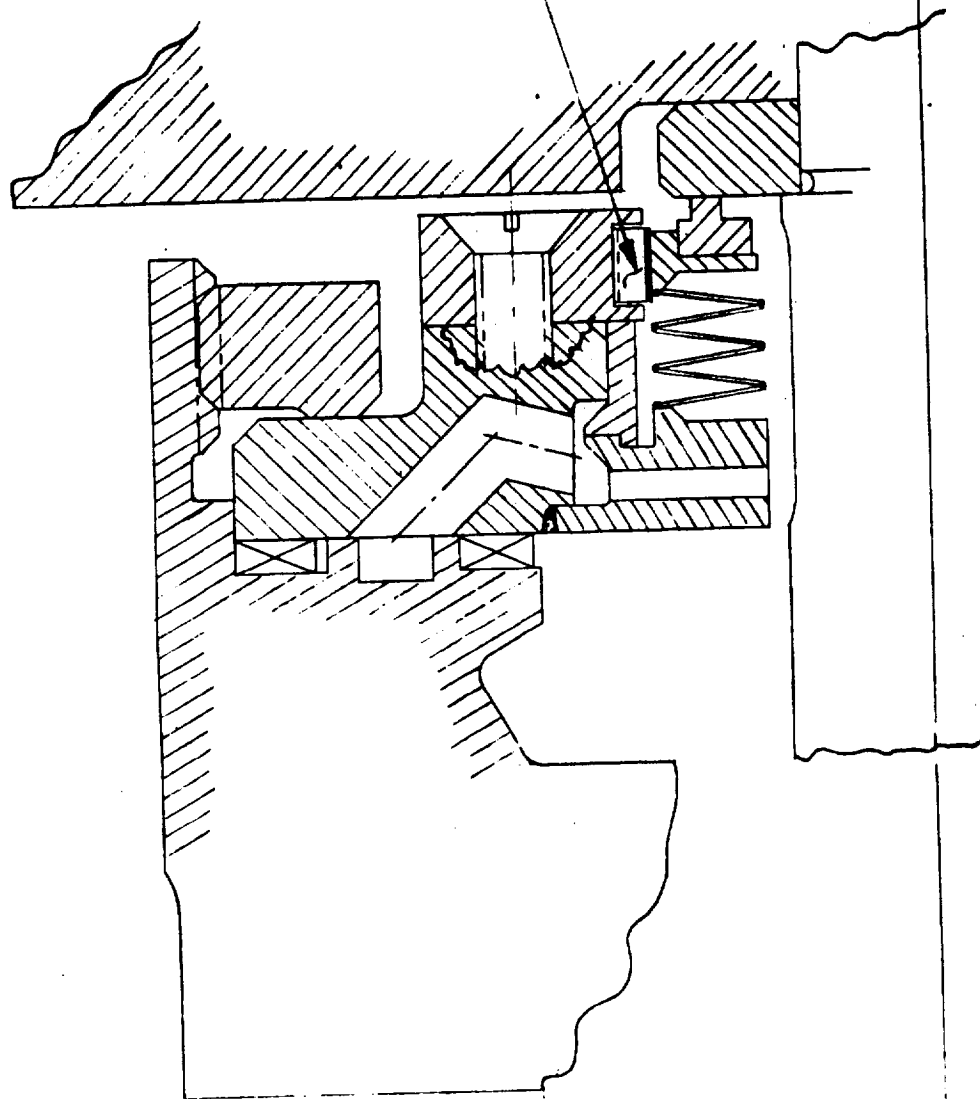
Figure 47. Mark 36 Pump Turbine Seal With Damper

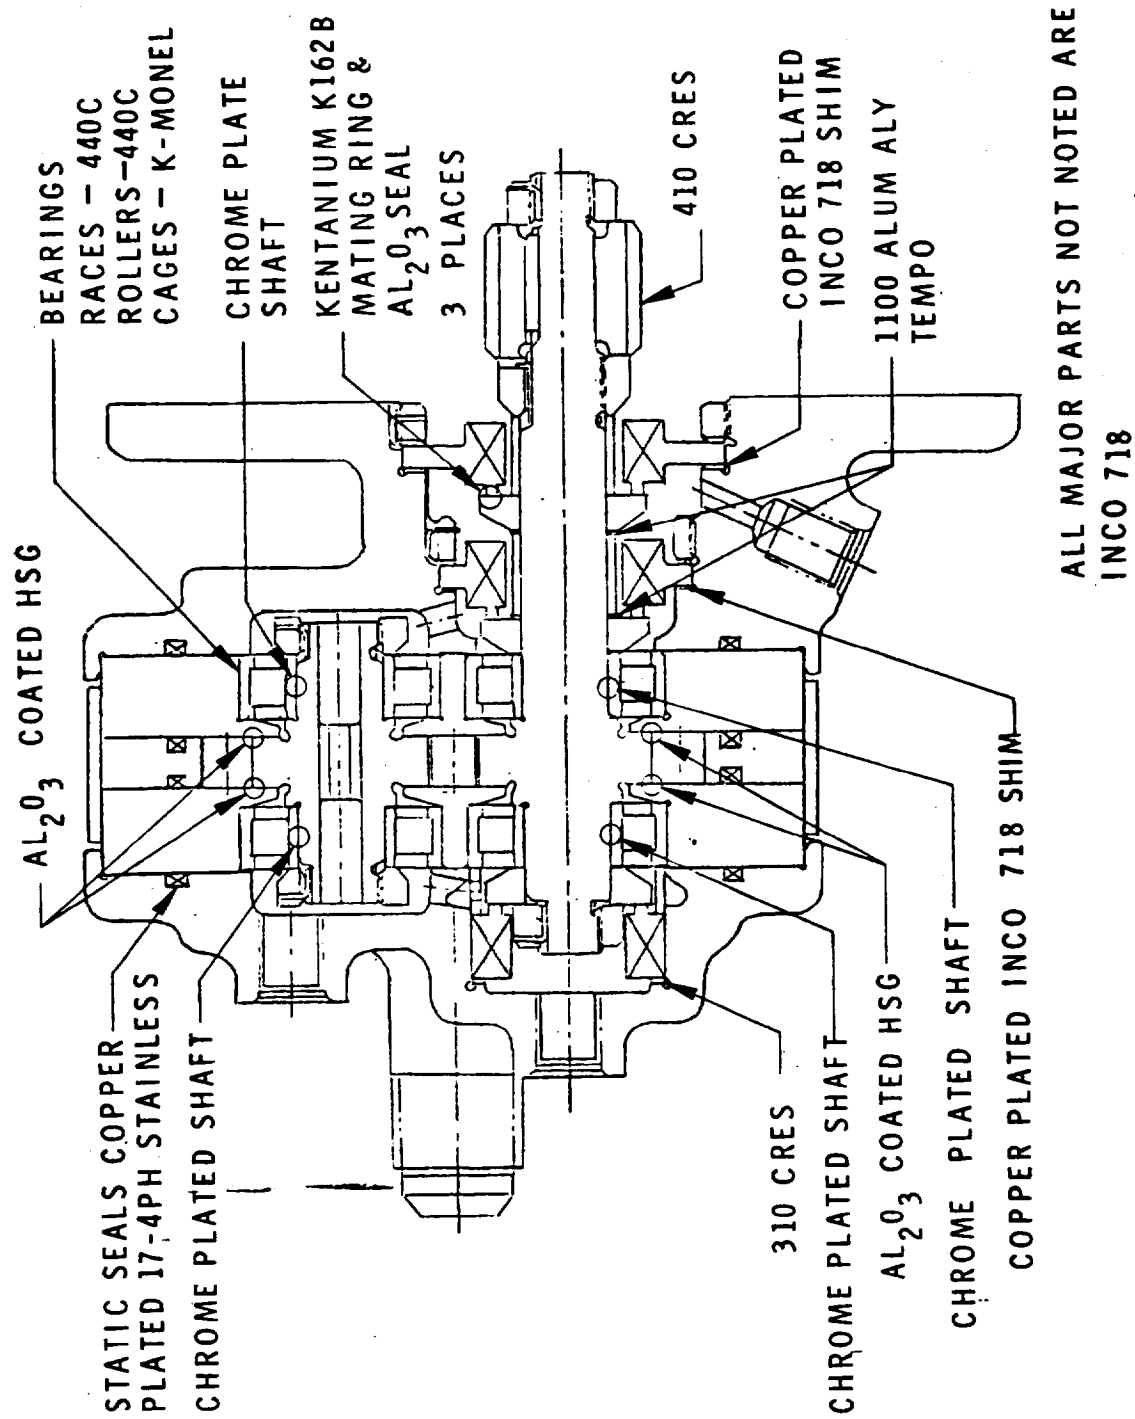
Figure 48. Mark 37 Pump

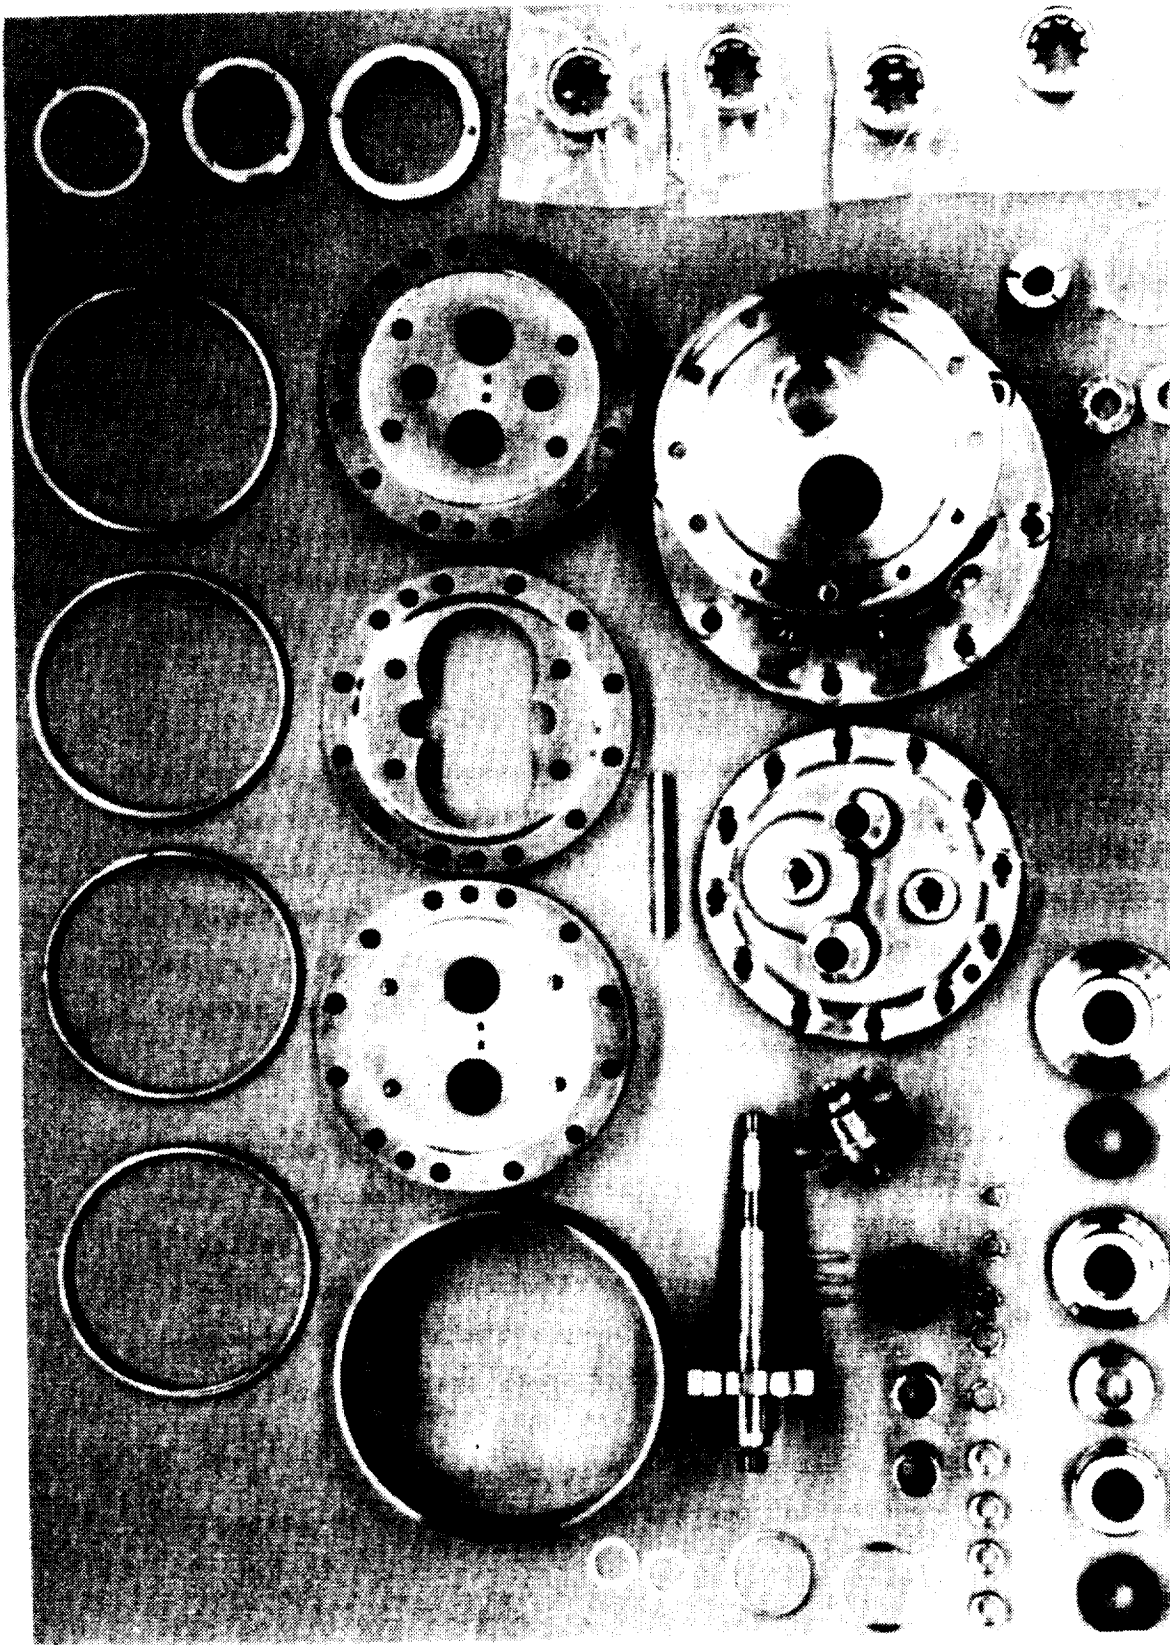
1XV52-2/25/70-C1

Figure 49. Mark 37 Gear Pump

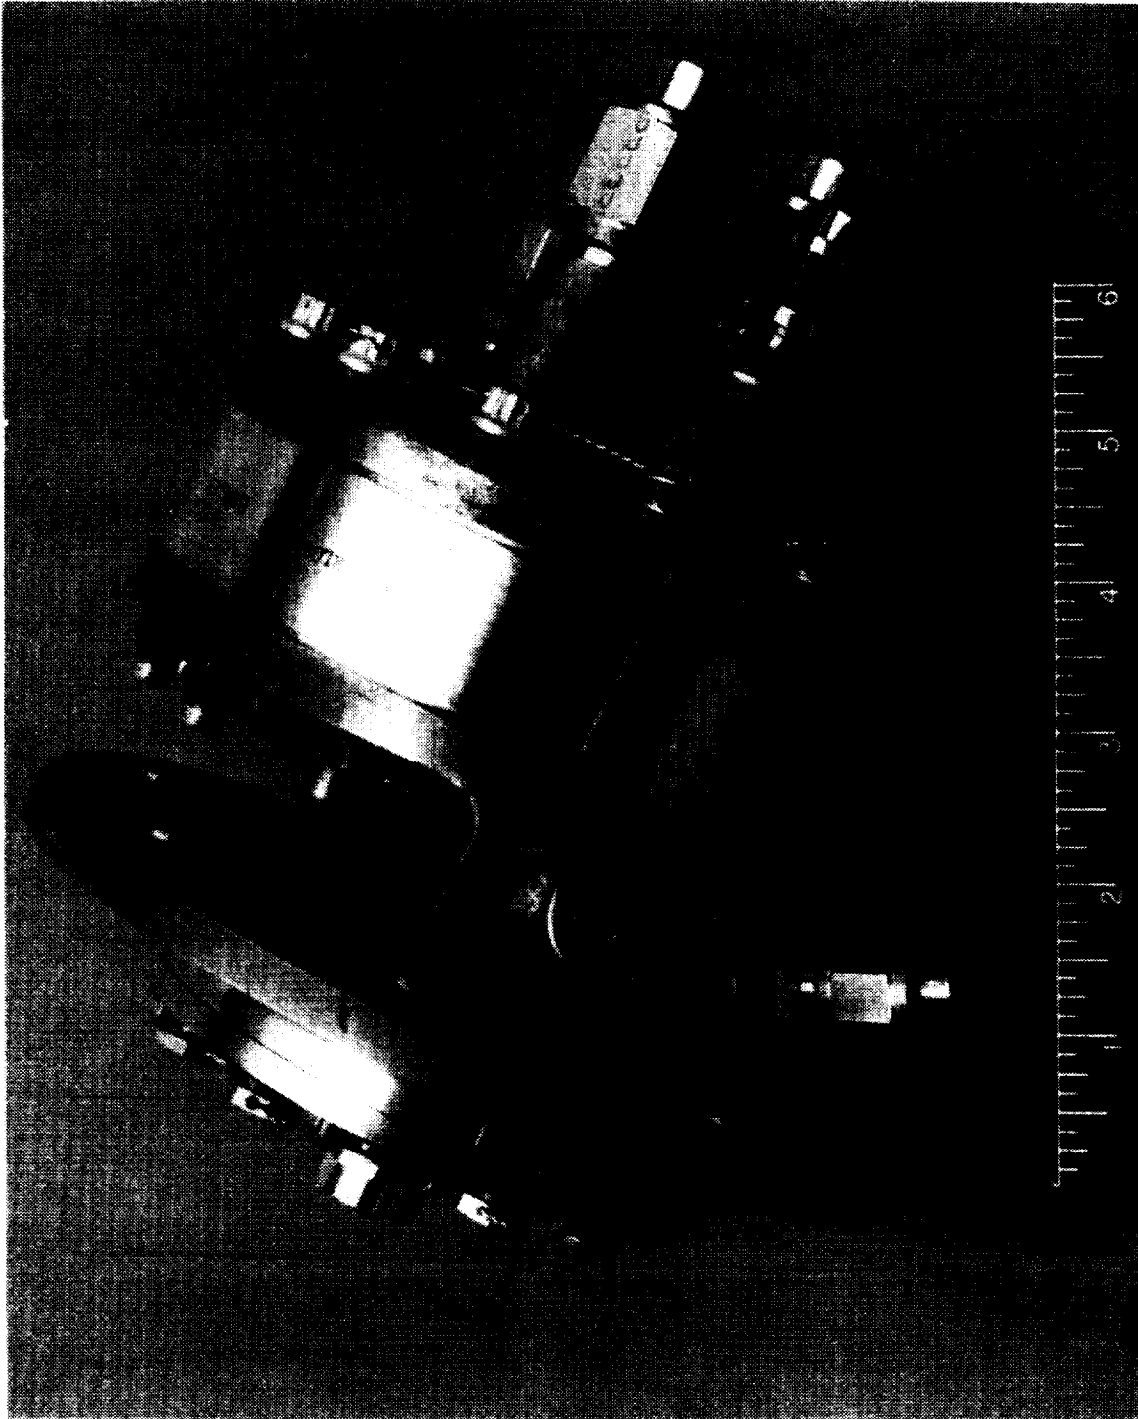
1XY52-3/11/70-C1

Figure 50. Mark 37 Gear Pump

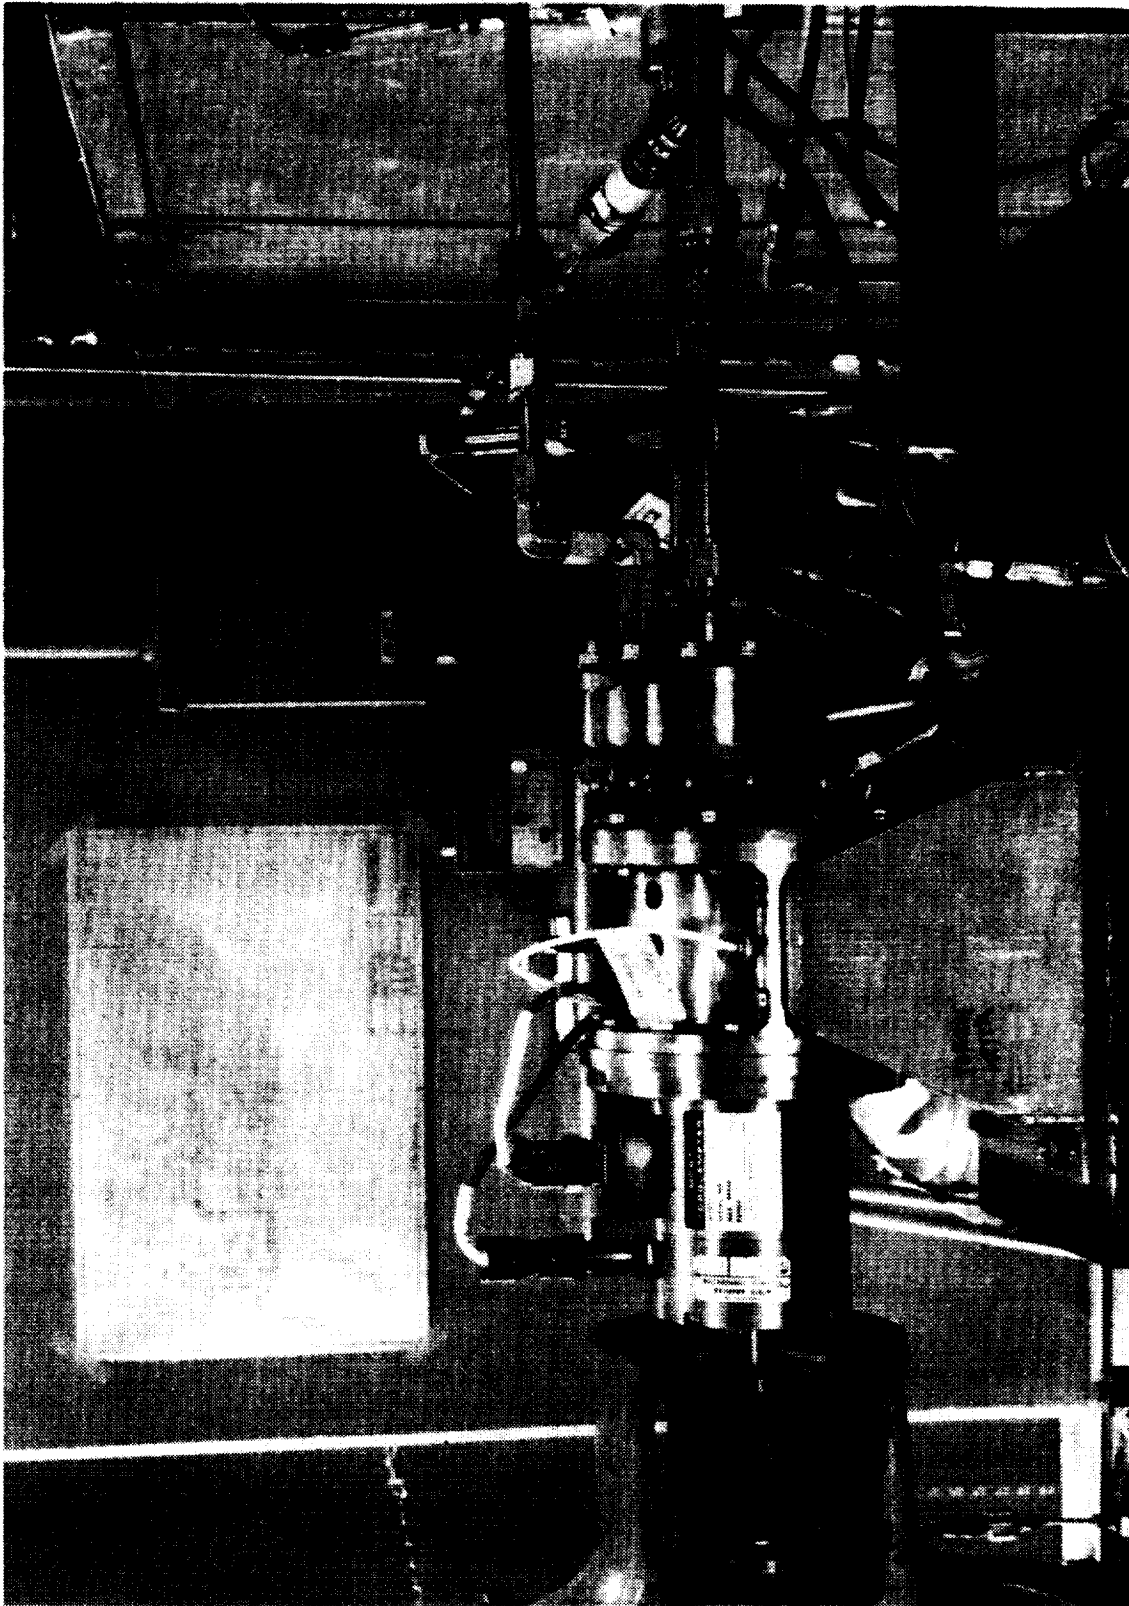
1EH94-3/24/70-C1D

Figure 52. Mark 37 Gear Pump Freon 12 Test Facility

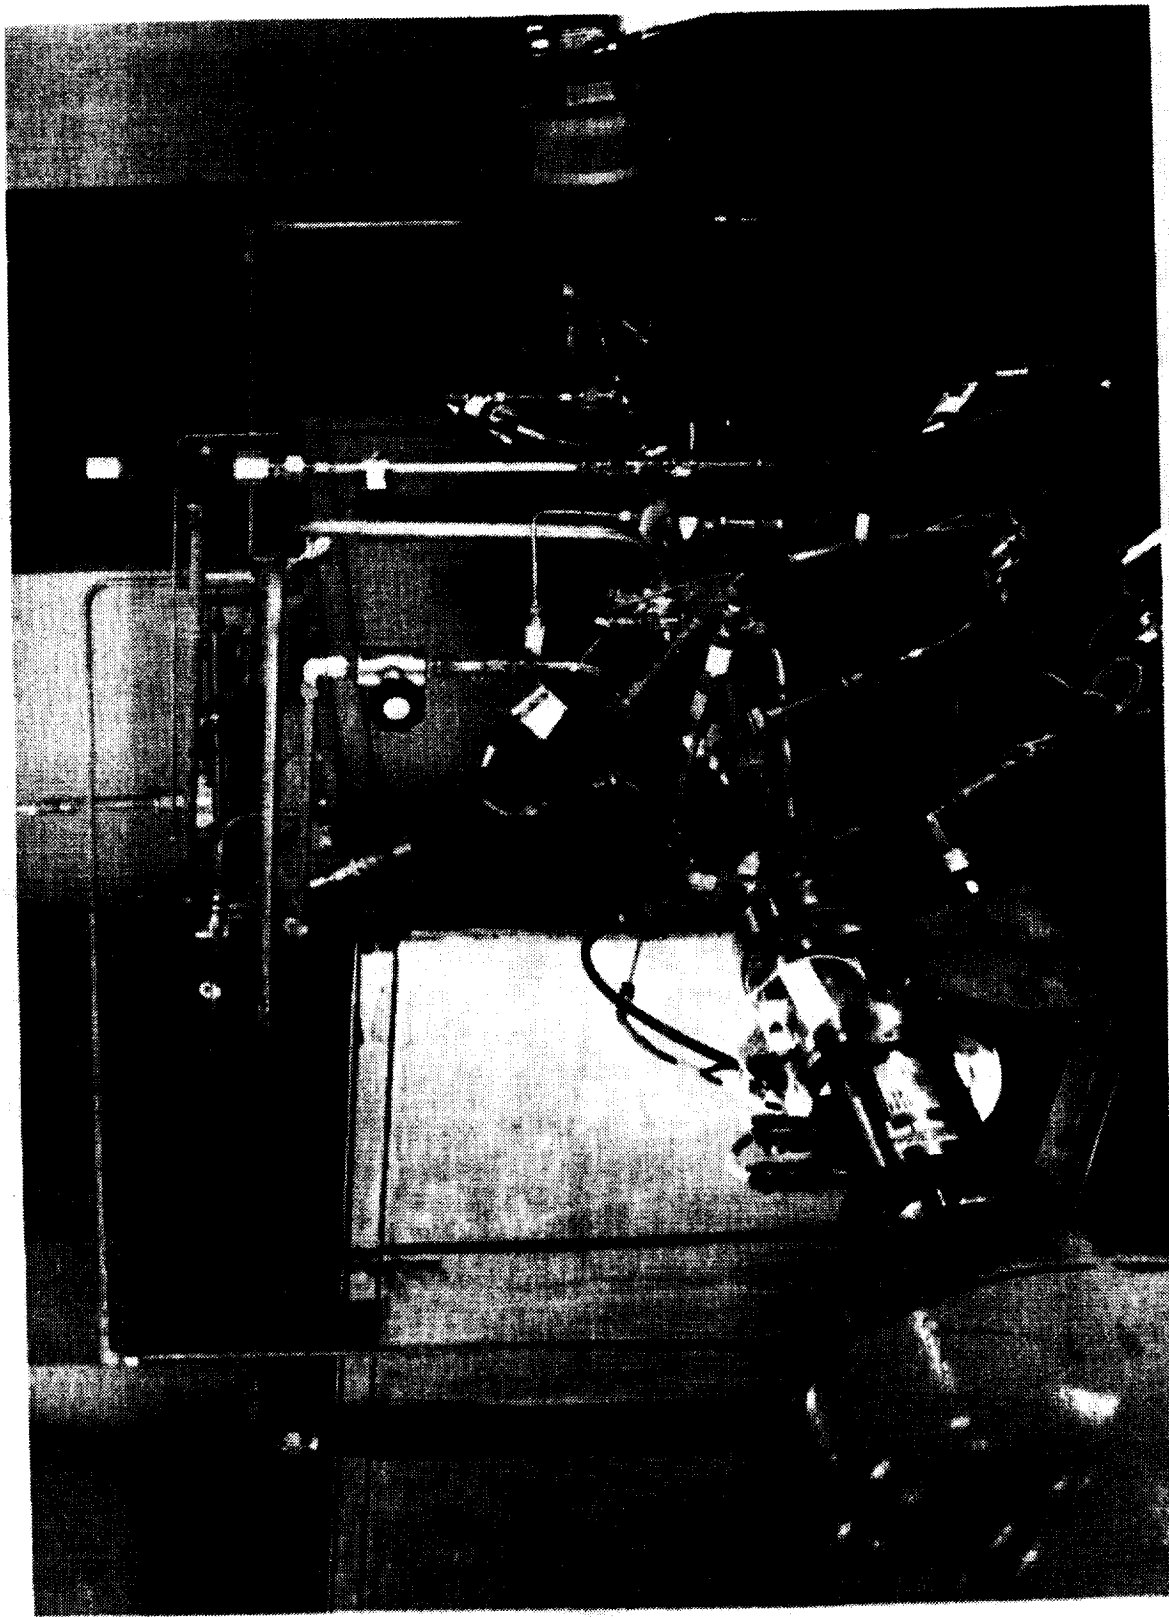
1EH94-3/24/70-C1B

Figure 53. Mark 37 Gear Pump Freon 12 Test Facility

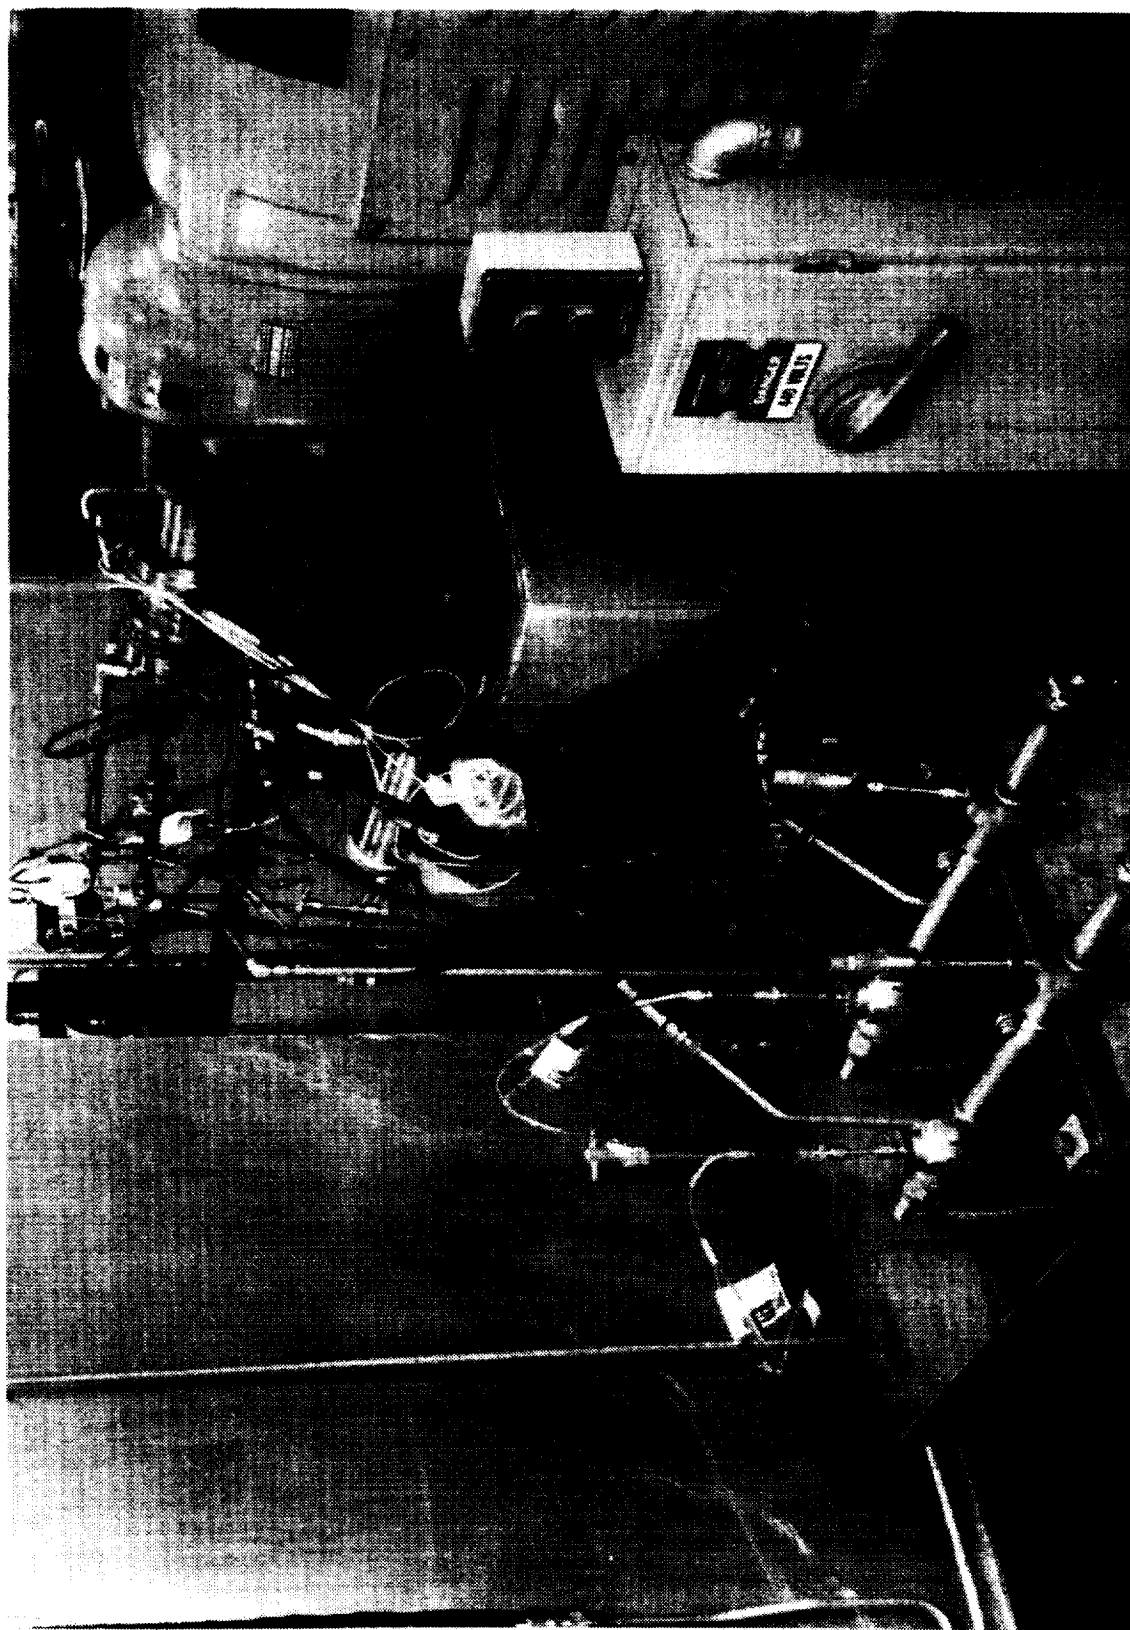
1EH94-3/24/70-C1C

Figure 54. Mark 37 Gear Pump Freon 12 Test Facility

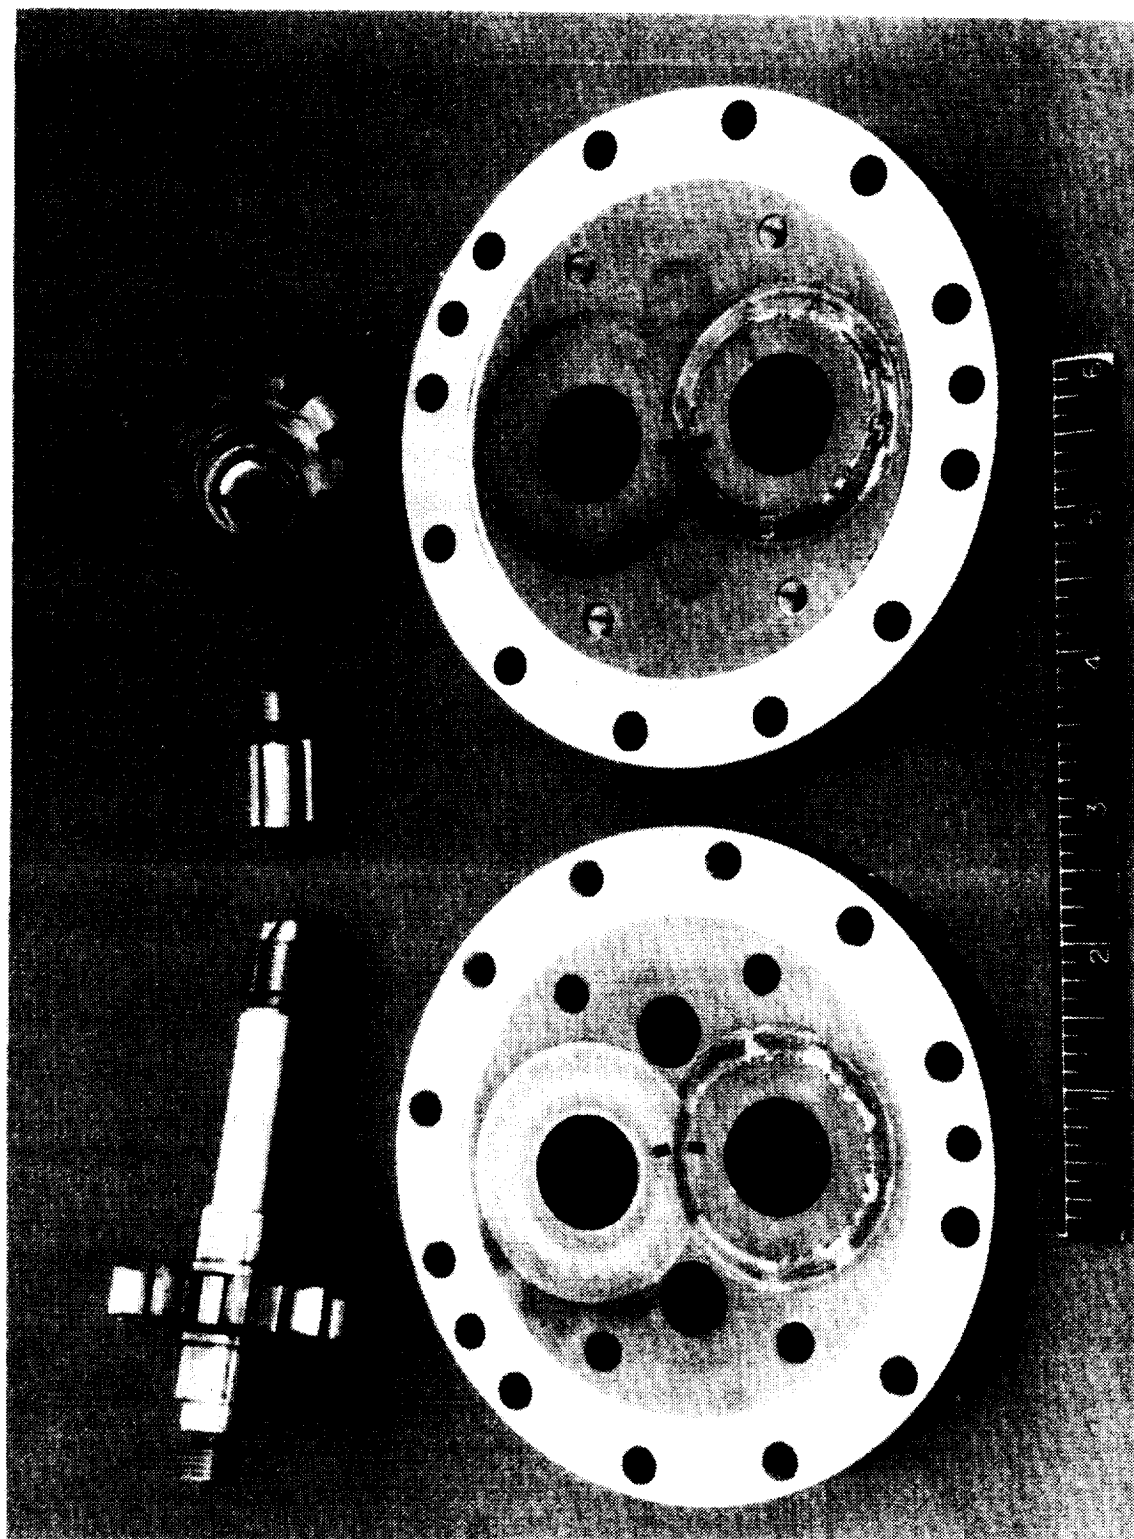
1XY55-4/16/70-C1

Figure 56. Mark 37 Gear Pump After Test No. 002

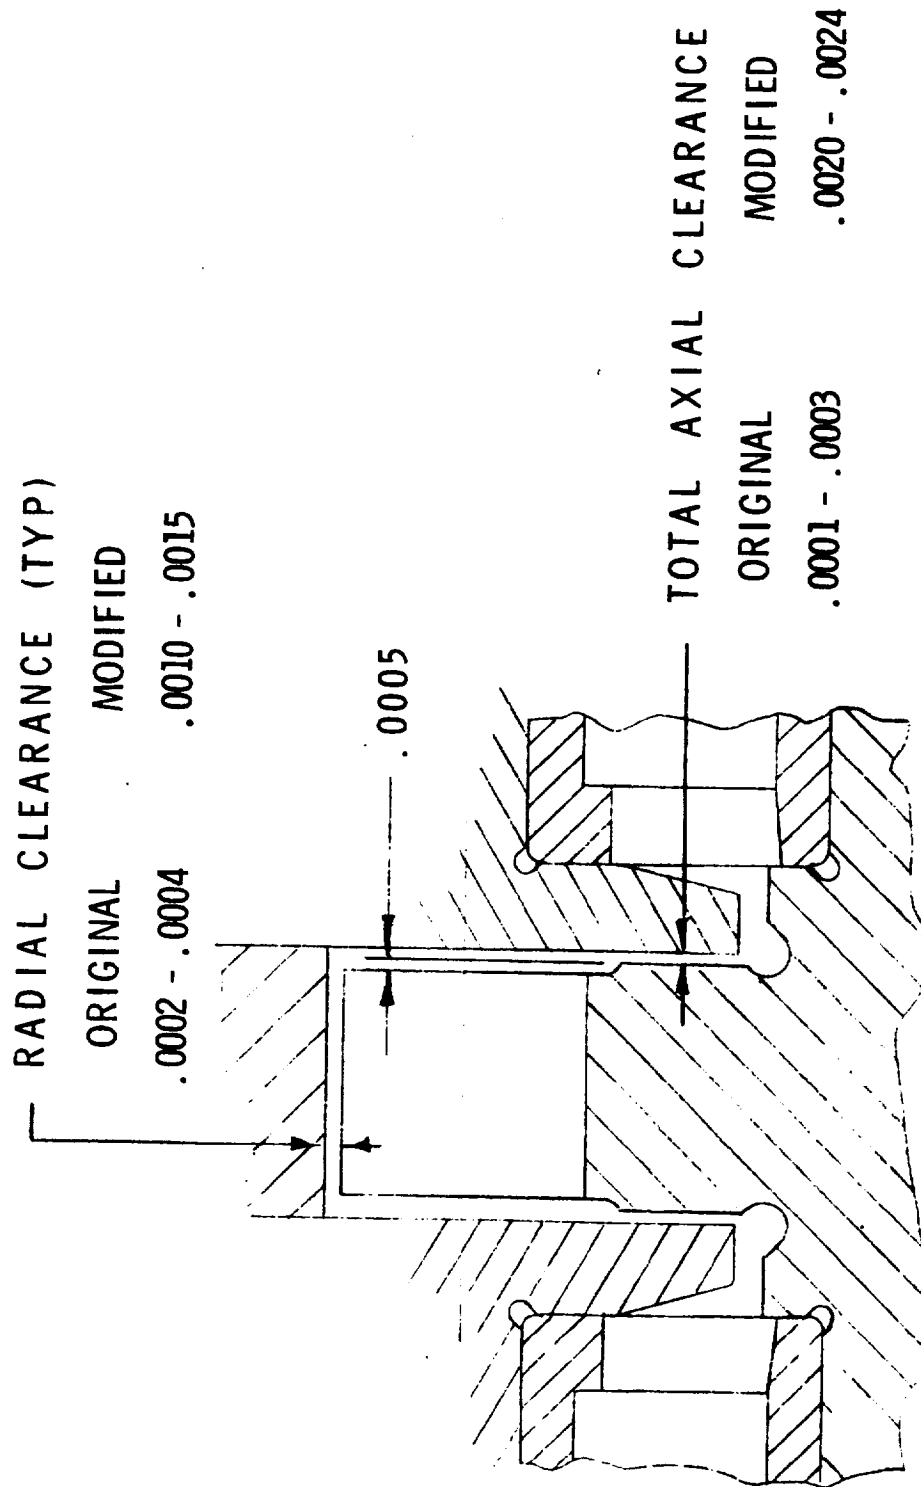
Hardware Modifications. From the results of the last test series, it appears that the aluminum-oxide coating on the side plates will not be able to take the scraping action of the gear teeth. To alleviate this problem, the gear faces were relieved 0.0005 inch (0.013 mm) on the side, opposite the gear teeth (Fig. 57). With this modification, any axial rubbing will take place

Figure 57. Mark 37 Pump Gear Tooth Relief

at the uninterrupted surface of the hub, and scraping action is eliminated. In addition, the clearance between the gear hub and the side plates was increased to provide a minimum of 0.001 inch (0.0254 mm) per side, resulting in a total axial clearance of 0.002-0.0024 inch (0.0508-0.061 mm).
